TITLE: Rehabilitation of TCE-Contaminated Underground Storm Water System Using Trenchless Technology

# REHABILITATION OF TCE-CONTAMINATED UNDERGROUND STORM WATER SYSTEM USING TRENCHLESS TECHNOLOGY

Michael A. Turco, P.E., DEE and Eric E. Huss  
Brown & Root Environmental  
993 Old Eagle School Road, Ste. 415  
Wayne, PA 19087-1710  
(610) 971-0900  
(610) 971-9715 telefax  
bbrf716@barms061.b-r.com

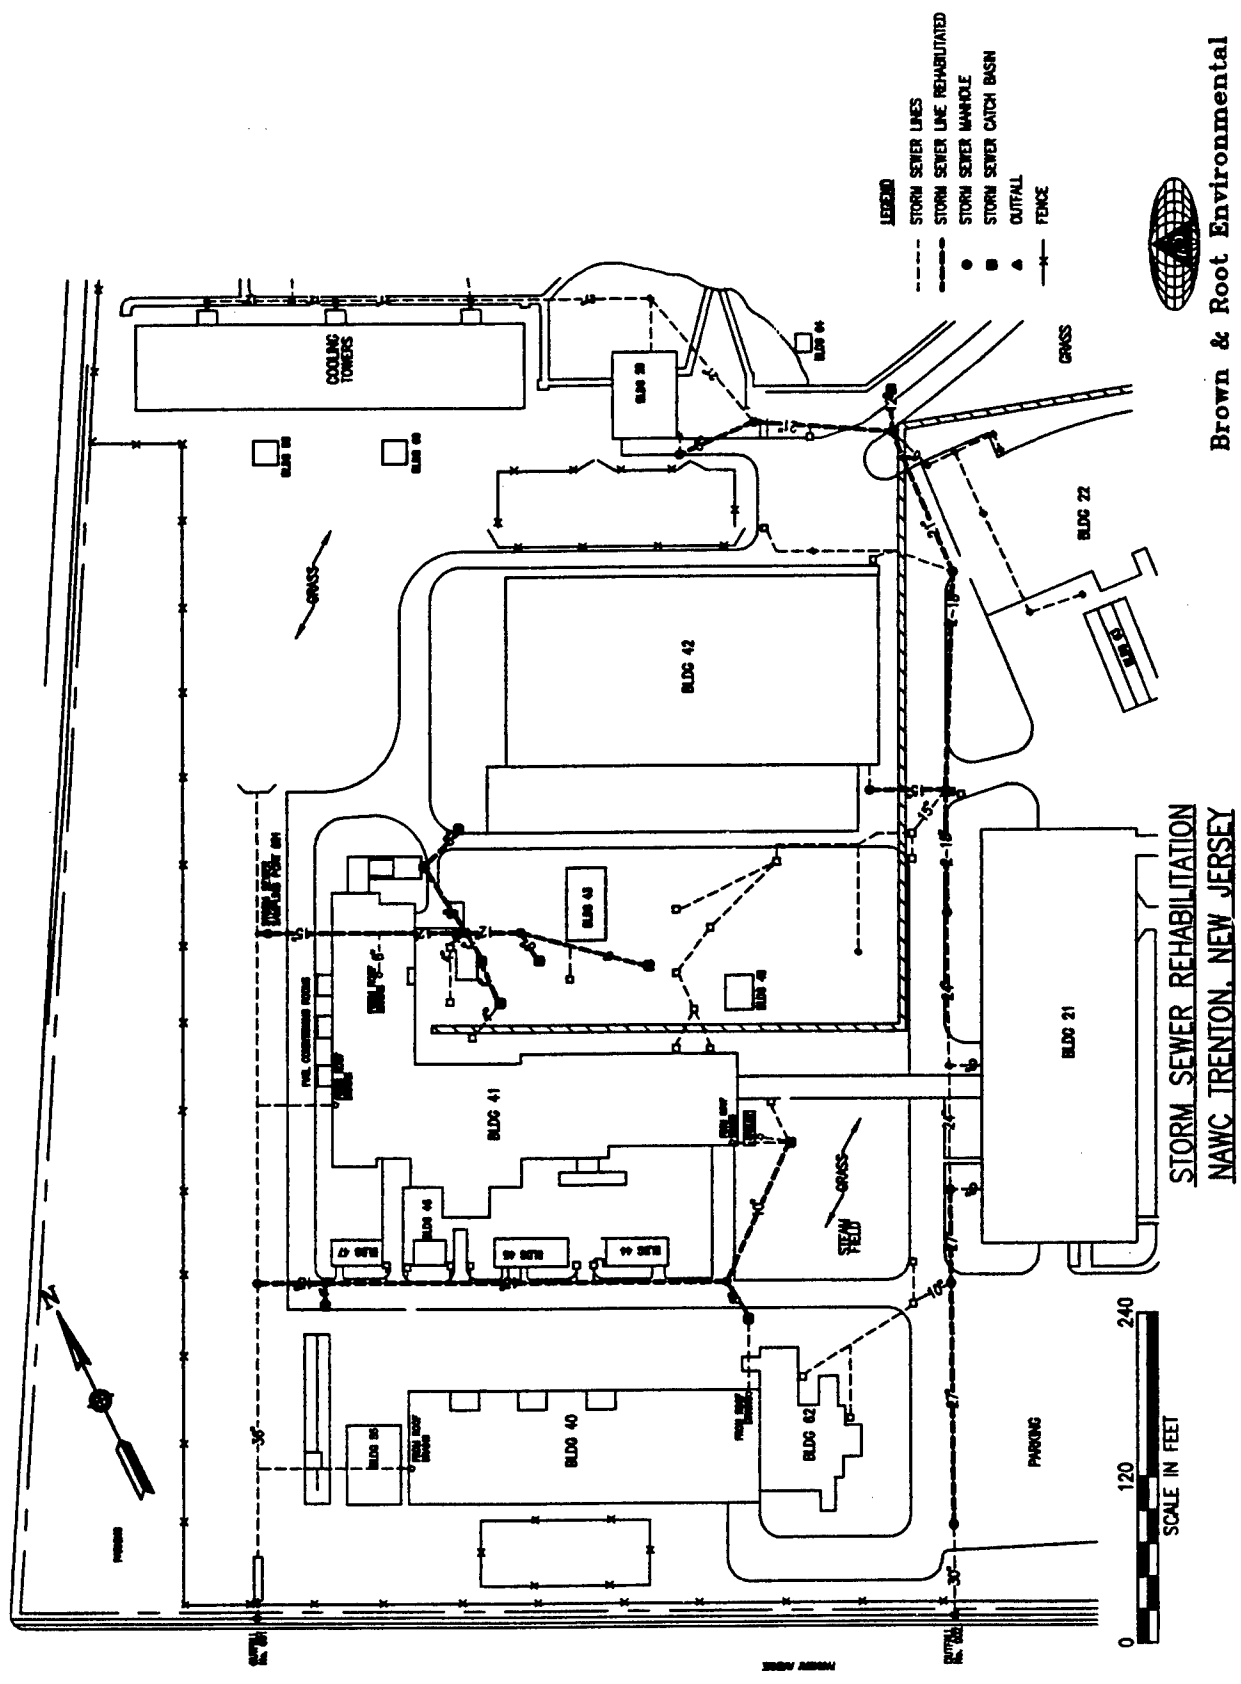
A field survey and sampling were conducted of all four areas of the site that drain through Outfalls 001 through 004. Inspection of all accessible manholes and inlets identified inconsistencies from the existing sewer drawings and the presence of flow from system connections. Sampling confirmed the presence of TCE in the storm sewer at locations identified during the remedial investigation, predominantly around Bldgs. 40, 41 and 42 that are situated in areas which drain toward Outfalls 001 and 002. In addition, flow of water was observed in the storm sewer during periods of no rain. Infiltration of TCE-containing groundwater to the storm sewers and/or exfiltration of TCE-containing process waters from the storm sewers was indicated. In light of these findings, B&RE's field efforts were focused on the storm sewer lines leading to Outfalls 001 and 002. (See Figure 1).

Figure 1. Site Plan of Outfalls 001 and 002 Storm Drainage Area - NAWC Trenton.  
Heavy dashed lines indicate sewer lines rehabilitated by CIPP technology.
